DEPARTMENT OF NATURAL RESOURCES
DIVISION OF OIL, GAS AND MINING

RE: Site Inspection, Kelly Hall Mine, S/047/058, Uintah County, Utah

Date of Inspection: May 19, 1994

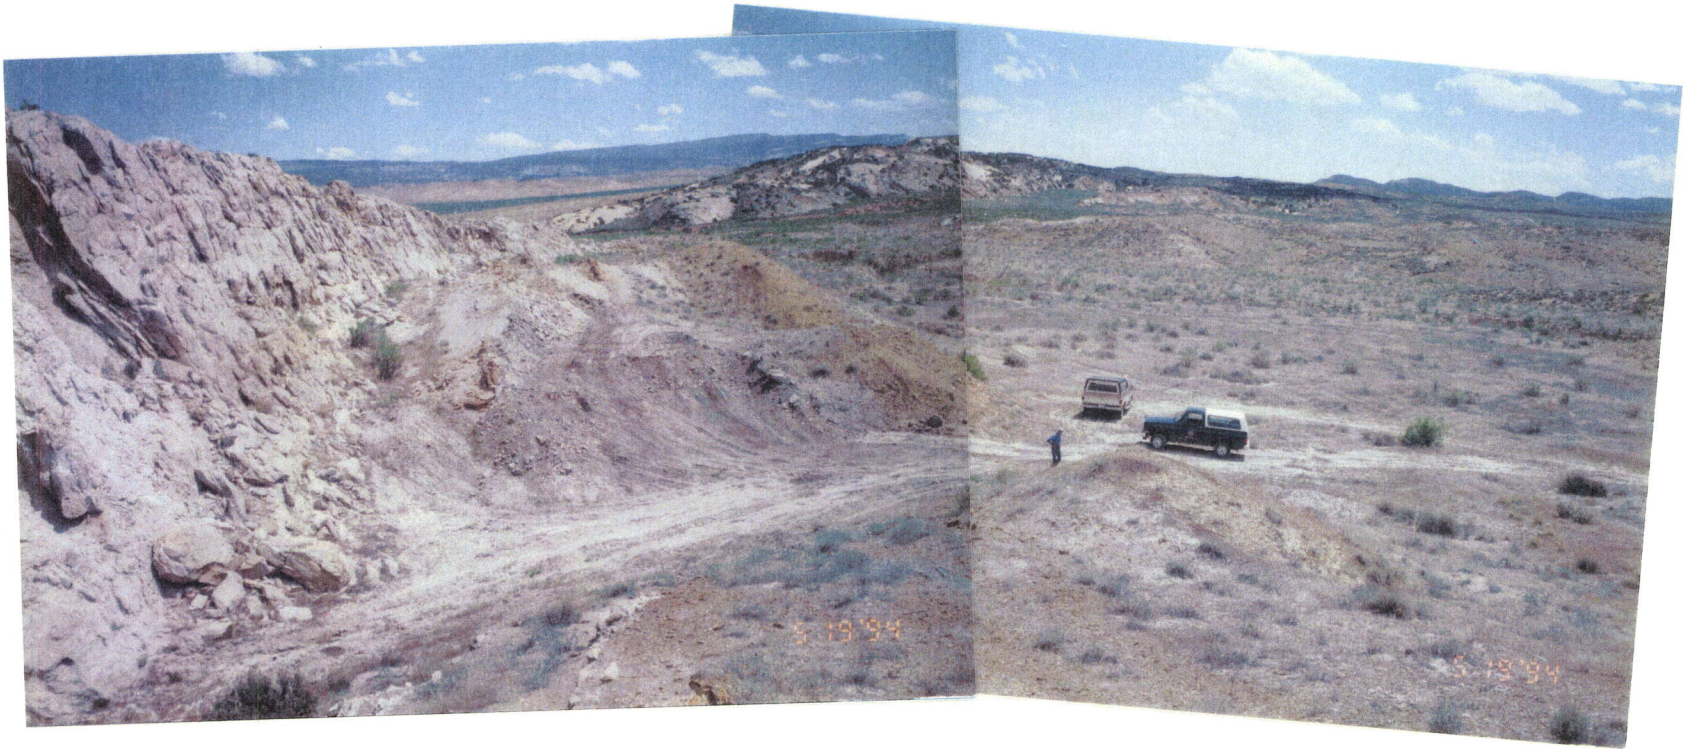
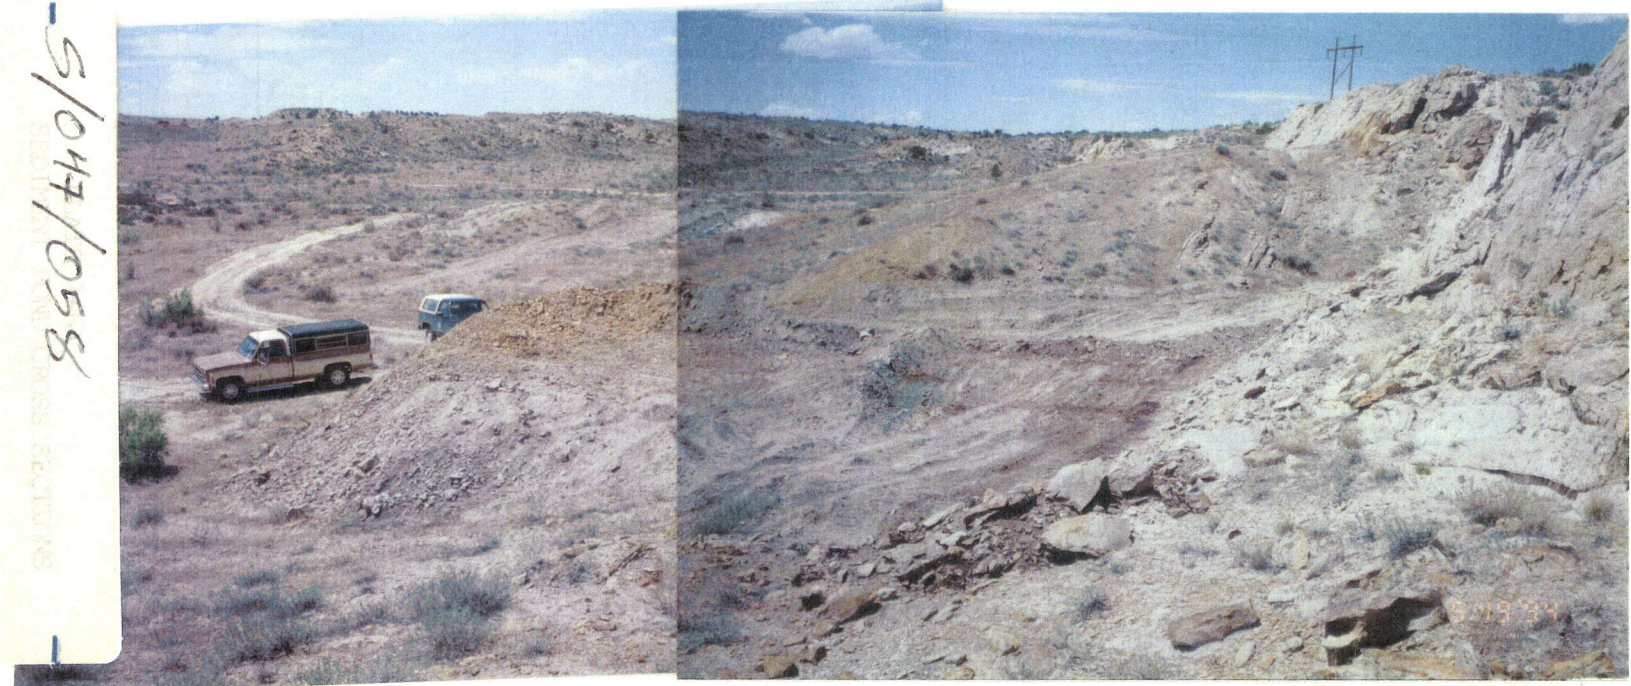
5/047/058

Photographs were taken, looking east and west at the mine disturbance. The amount of existing vegetation can be seen in the photographs. I informed Mr. Hackford that after July 1, 1994, Division of State Lands and Forestry would be changed and the management of State Lands would be handled by a different agency. I had no information as to who would be the contact for that or where that agency would be located.
